1 Problem

Tacoma Narrows Bridge Collapse

Cause Map™ Diagram

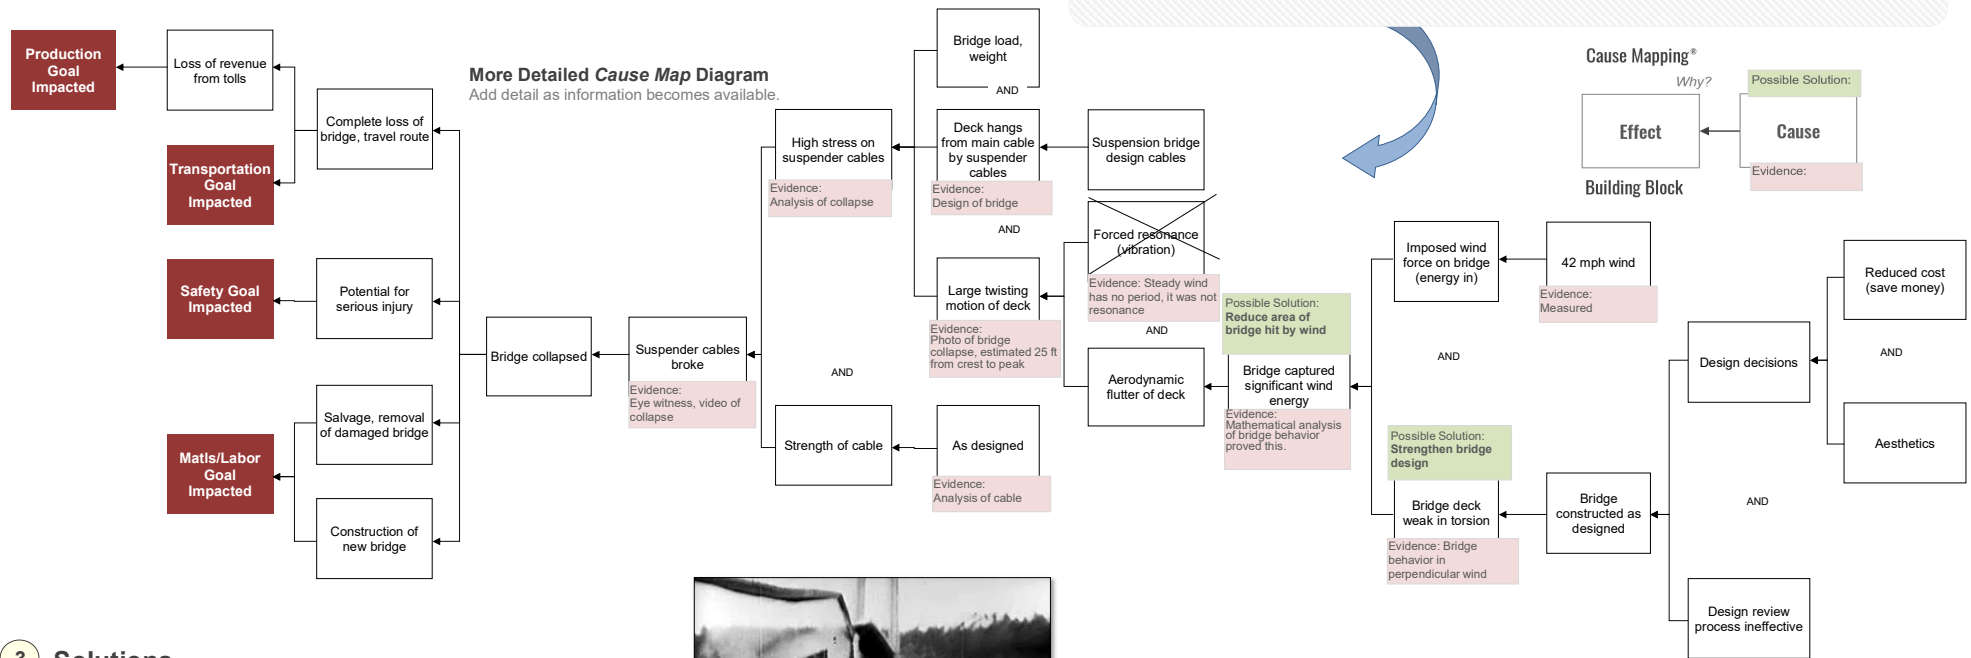
As the Cause Map diagram demonstrates there were many causes that contributed to the collapse of the bridge. Wind was one of the more obvious causes. On the day the bridge failed, the wind was blowing across the roadbed at 42 mph, the strongest wind the bridge had experienced. Another cause was the design of the bridge. The Tacoma Narrows Bridge was particularly narrow relative to its length, making the roadbed more flexible than other suspension bridges. Additionally, the bridge had shallow girders and was relatively weak in torsion compared to other suspension bridges built around the same time. The overall design of the bridge resulted in a structure that was weak in torsion and moved relatively easily in the wind.

In addition to the mechanical causes that contributed to the failure, there were a number of issues with the design process. One of the primary drivers behind the bridge design was cost reduction. The first design proposed for the Tacoma Narrows Bridge was a conventional suspension bridge that was estimated to cost \$11 million. The price of the bridge design that was actually built was of \$3 millions dollars cheaper. Additionally, the approved design was considered to be much more elegant and aesthetically pleasing. As in the case of all designs that failure, the design review process was also ineffective or the design flaws that contributed to the bridge collapse would have been identified prior to construction.

Ref.	Possible Solution	Cause
1	Wider roadbed	Narrow in relation to length
2	Stiffening struts	Roadbed was too flexible
3	Open lattice trusses	Solid trusses
