Cause Map

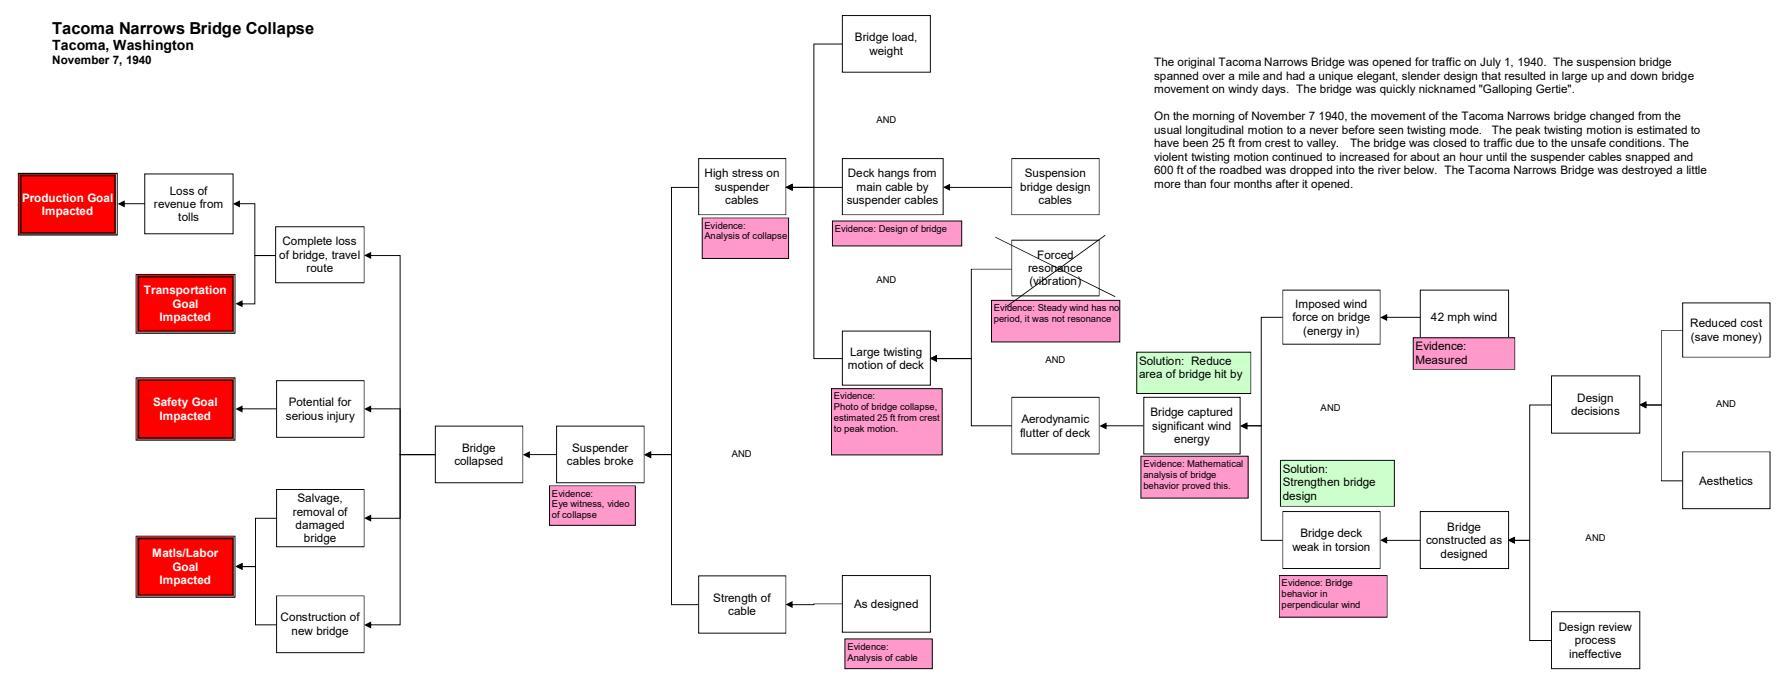
As the Cause Map Demonstrates there were many causes that contributed to the collapse of the bridge. Wind was one of the more obvious causes. On the day the bridge failed, the wind was blowing across the roadbed at 42 Dm, the strongest wind the bridge had experienced. Another cause was the design of the bridge. The Tacoma Narrows Bridge was particularly narrow relative to its length, making the roadbed more flexible than other suspension bridges. Additionally, the bridge had shallow girders and was relatively weak in torsion compared to other suspension bridges built around the same time. The overall design of the bridge resulted in a structure that was weak in torsion and moved relatively easily in the wind.

In addition to the mechanical causes that contributed to the failure, there were a number of issues with the design process. One of the primary drivers behind the bridge design was cost reduction. The first design propsed for the Tacoma Narrows Firdge was a conventional suspension bridge that was estimated to cost \$111 million. The price of the bridge design that was actually built was of \$3 millions dollars cheaper. Additionally, the approved design was considered to be much more elegant and aesthetically pleasing. As in the case of all designs that failure, the design review process was also ineffective or the design flaws that contributed to the bridge collapse would have been identified prior to construction.
