I-35 BRIDGE COLLAPSE

How an Unchecked Assumption Brought Down a Bridge

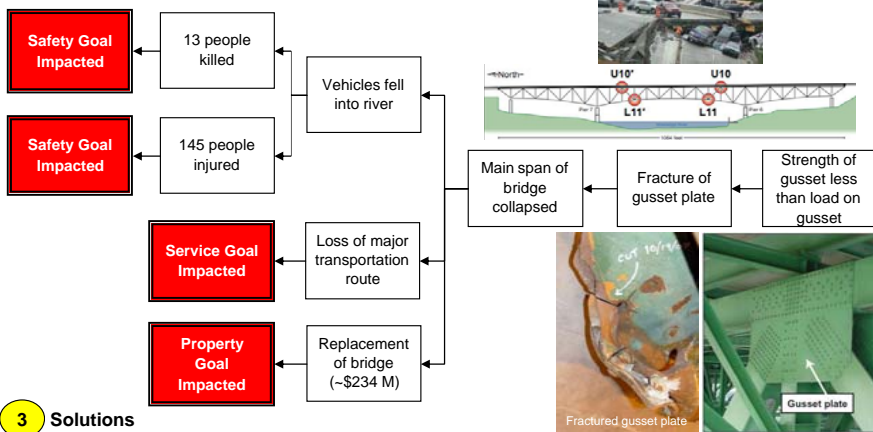
More Detailed Cause Map - Add detail as information becomes available.

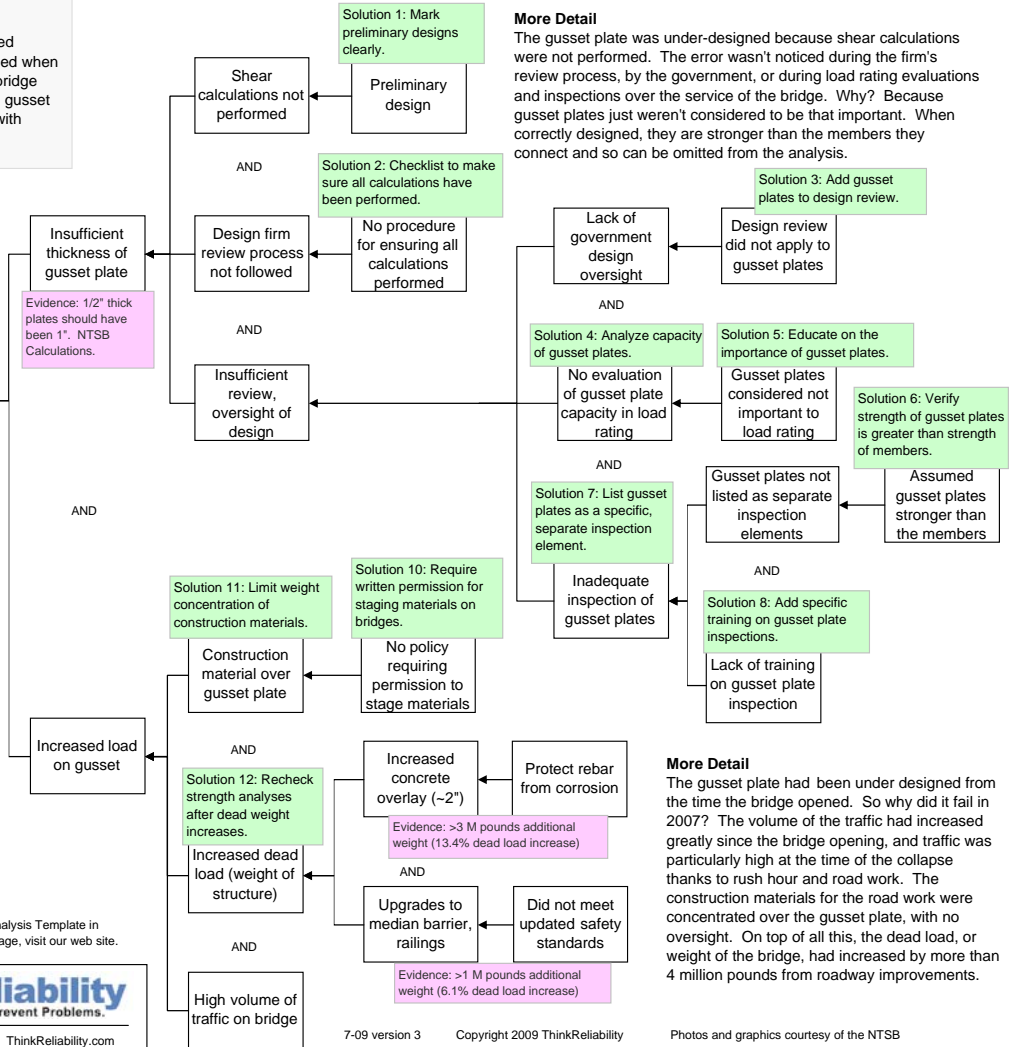
For a free copy of our Root Cause Analysis Template in Microsoft Excel, used to create this page, visit our web site.
