Hyatt-Regency Walkway Bridge Collapse

July 17, 1981 Kansas City, MO

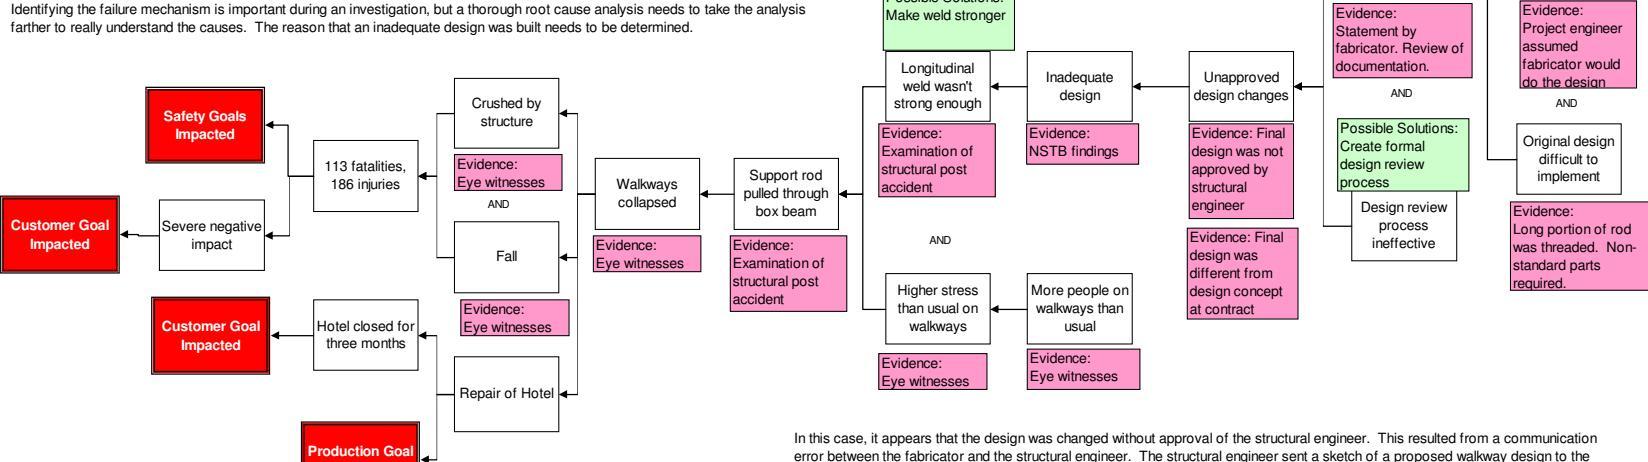
A root cause analysis of this accident shows that there were a number of causes that contributed to the walkways collapsing. Investigation into the accident shows that the structural design of the walkway was inadequate. A weld failed which allowed a support rod to pull through the box beam and the walkways fell.

Additionally, the weld had greater stress than normal on it at the time of the failure because a large crowd had gathered to watch a danced content. About 20 people were on second floor walkway and about 40 were on the fourth floor walkway at the time of the accident. The higher loading combined to the walkway collapse.

dramatically decreased the load bearing capacity of the walkways.

supporting the weight of the second floor walkway, which it wasn't designed to handle.

The original design called for continuous hanger rods (a non-standard part that would have needed to be manufactured) that passed

both walkways. The fabricator changed the design to use two shorter rods (standard parts) which resulted in the fourth floor walkway

through the fourth floor walkway beam box to the second floor walkway, resulting in the ceiling connecting supporting the weight of
