## **Deepwater Horizon Oil Spill**

Well blowout, explosion on rig, fatalities

Cause Map<sup>™</sup> Diagram

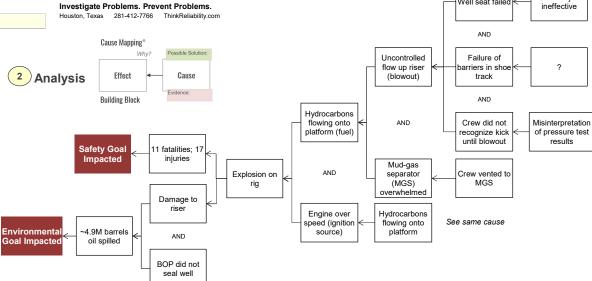
The Cause Map diagram is used to identify all the possible solutions for given issue so that the best solutions can be selected. The possible solutions can also provide backup plans in case the initial solutions selected didn't work, as happened in this case.

Plan A: The first plan (action item) was to attempt to use functionality within the blowout preventer (BOP) which had failed to seal the well. It didn't work. Attempts to intervene with the BOP ended May 5th

Plan B: Plan B involved the installation of a cofferdam, a dome that would be placed over the leak and divert the oil to a surface ship. The cofferdam reached the bottom of the Gulf May 7th, but couldn't be forced down over the leak

Plan C: The next plan was to use a Riser Insertion Tube Tool (RITT) that would siphon some of the flow from the end of the riser and redirect it to a surface ship for collection. The RITT did divert some of the flow., but not all.

Plan D: The next plan aimed to end the flow from Macondo well by ramming heavy mud and cement directly into the well itself. The operation was stopped when it became clear the mud was no match for the flow from the well.

Plan E: The next plan attempted to capture ALL the flow with a 3-ram capping stack, and divert it to two surface ships. The cap was finally placed on July 12th and the flow was choked on July 15th. Now the flow was captured, but the Macondo well was still releasing oil at a high rate.

Plan F: Plan F had been a long time in coming. The relief wells were dug in starting on May 2nd with the plans of intercepting and pumping mud, then cement, down into the Macondo reservoir, a permanent fix to the spill (known as a "static kill"). The static kill was completed on August 4th. That still wasn't the end. The last cement was placed on September 18th and it was announced that the well was 'effectively dead'.
