OceanGate Titan Implosion - 5 fatalities

Location of Incident	OceanGate, North Atlantic
Date of Incident	June 19, 2023
Date of Final Report	DRAFT September 24, 2024

Cause Mapping®

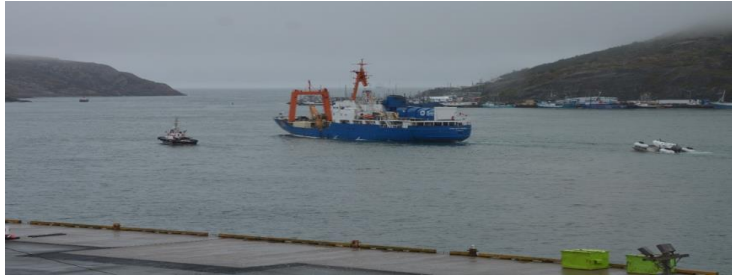
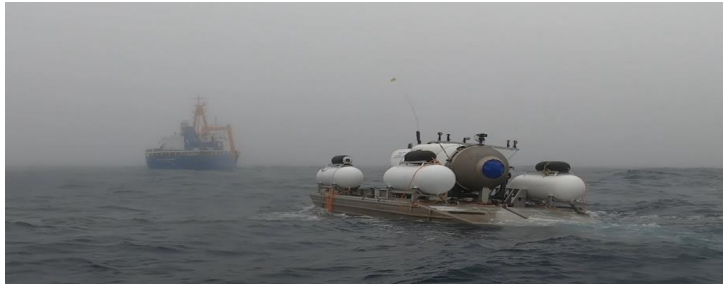
TITAN submersible with Launch and Recovery System in tow behind the Polar Prince

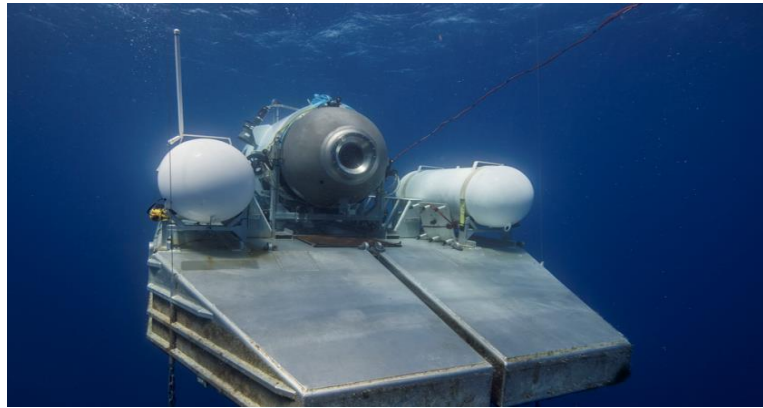
TITAN mounted on Launch and Recovery System

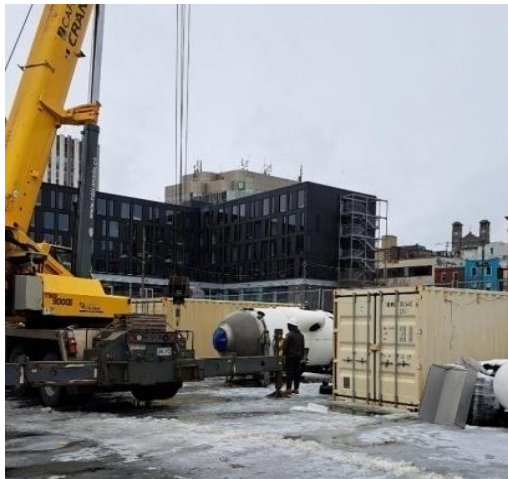
Picture of typical storage for TITAN submersible in winter

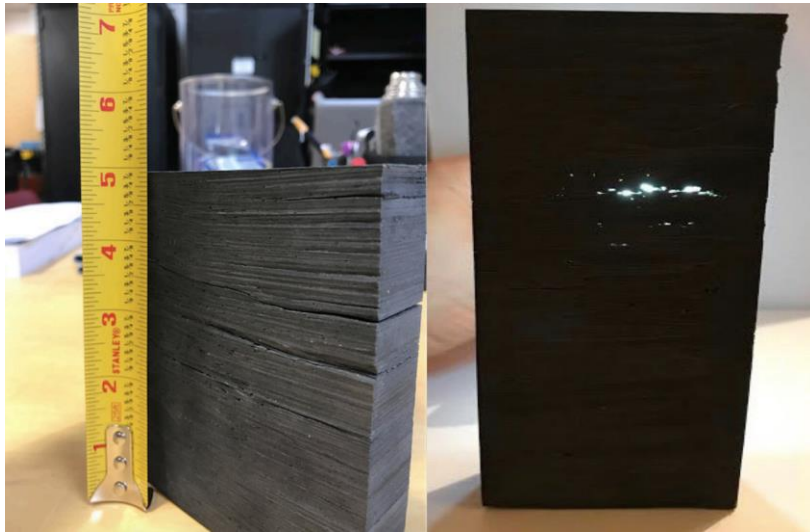
Cut off of carbon fiber pressure vessel, indicating multiple delaminations, voids in carbon fiber

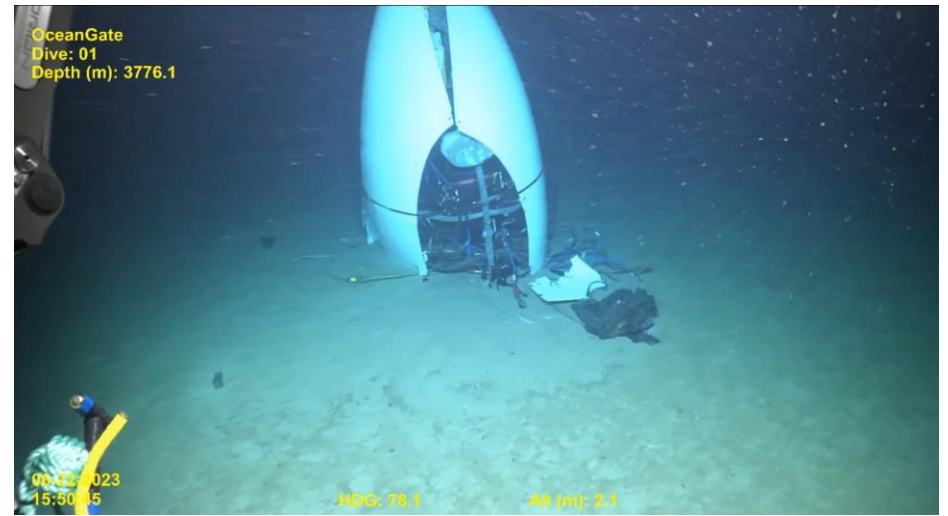
Rear fairing, as found on seafloor at 3776M deep near titanic wreckage

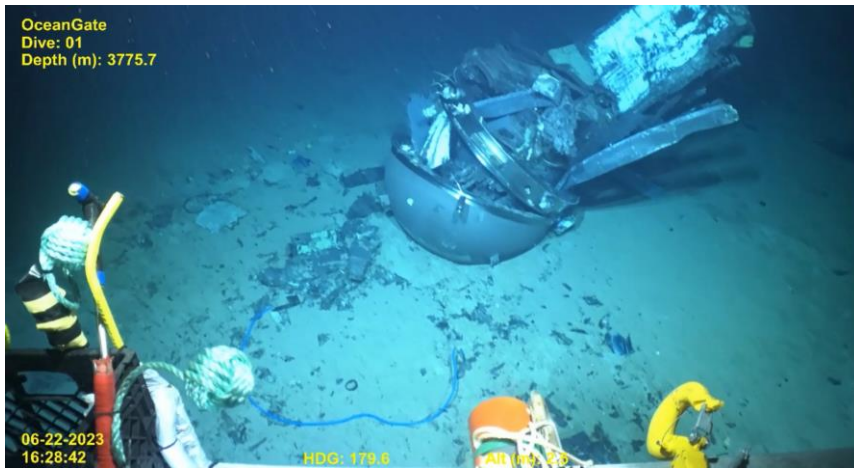
Rear Titanium hemisphere and carbon fiber pressure vessel as found on ocean floor

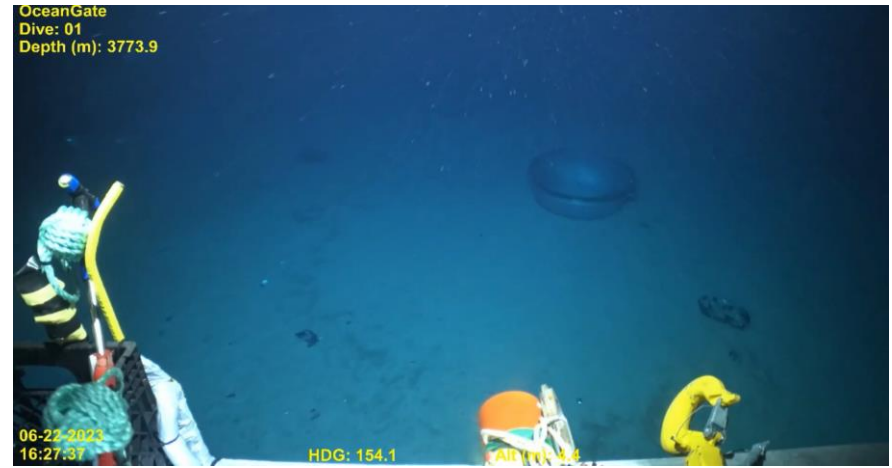
Front titanium hemisphere, as found on ocean floor

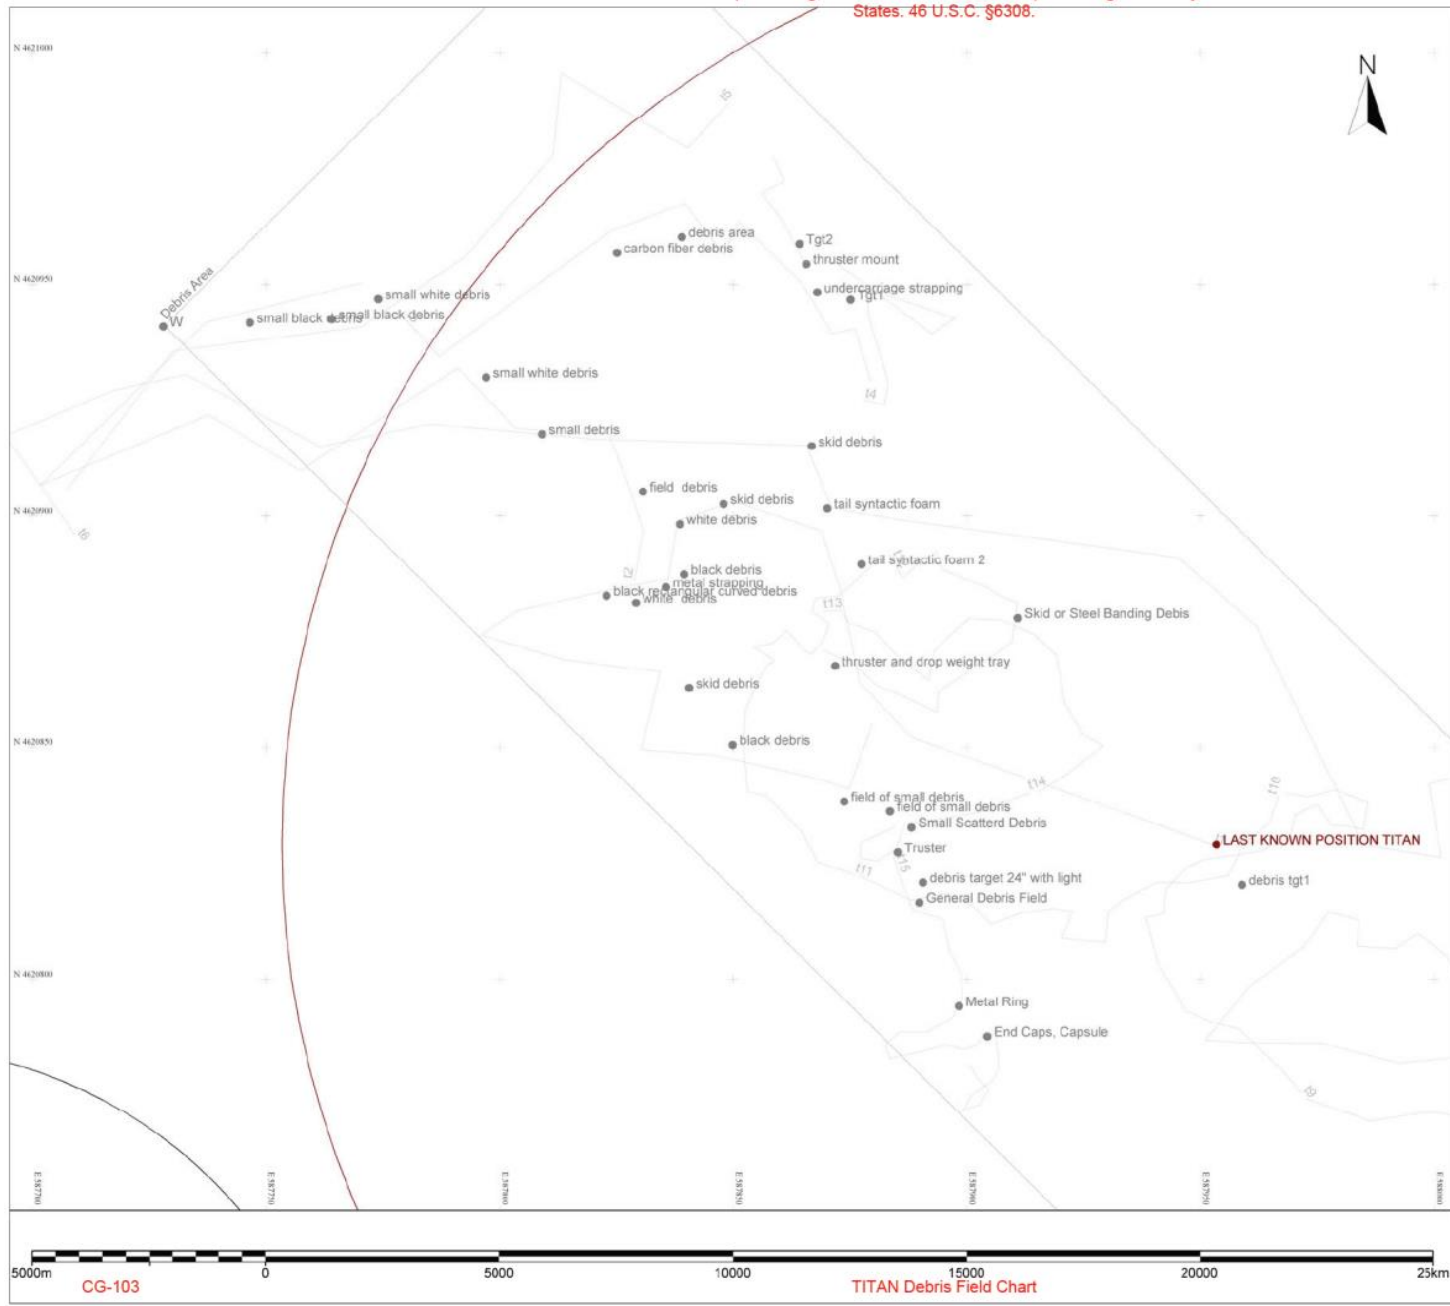
Diagrams - Debris Field

Description	Easting	Northing
	utm 22N	utm 22N
	meters	meters
Titanic Bow	587668	4620686
Last Known Position TITAN	587953	4620829
South	487962	4620706
West	587728	4620941
North	587821	4621034
East	588055	4620799

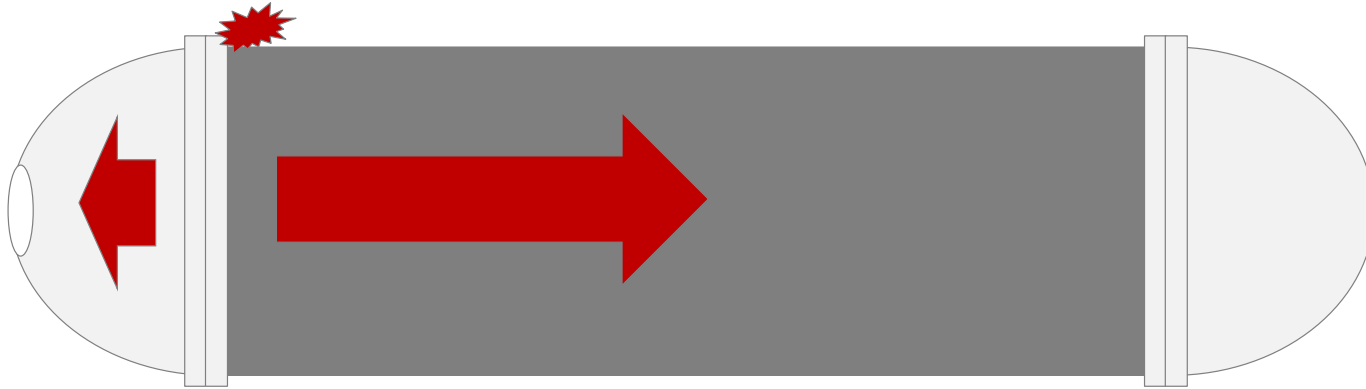
Approximate theory of forces associated with end ring failure

No.	Information and Evidence to Collect	Owner	Date Created
1	Perform failure analysis, and inspect glue joint on end ring recovered from the incident	US Coast Guard NTSB	September 24, 2024
2	Perform FEA on effects of repeated dives and difference in thermal expansion	US Coast Guard NTSB	September 24, 2024
3	Get layup process of carbonfiber, look at any NDE post wrapping to see if NDE was performed	US Coast Guard NTSB	September 24, 2024
4	Collect data regarding cyclic effects on carbon fiber cylinders	US Coast Guard NTSB	September 24, 2024
5	Get spec sheet on epoxy utilized for joint and investigate effects of large external pressure and temperatures with repeated cycling	US Coast Guard NTSB	September 24, 2024

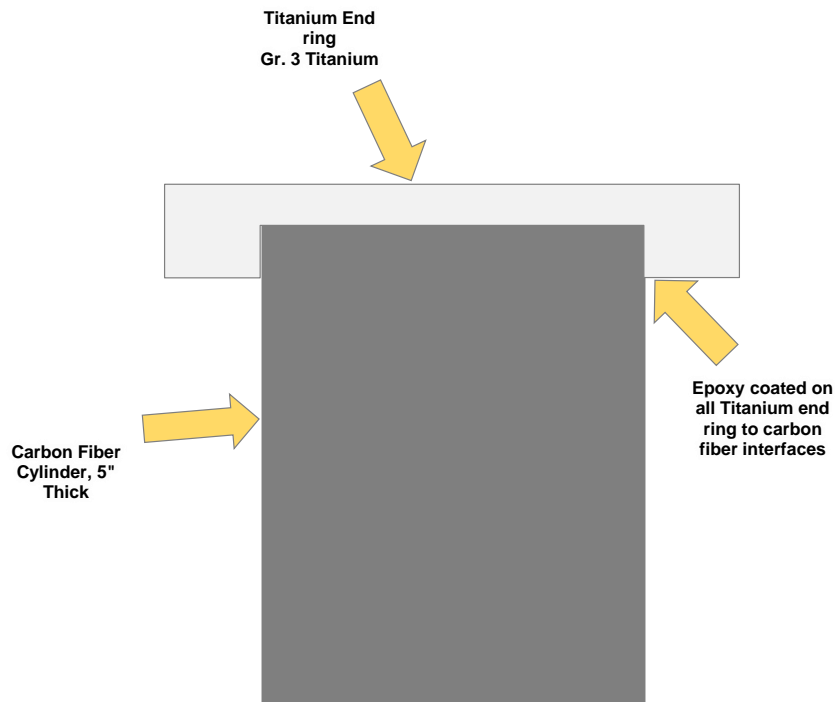
Approximate joint interaction of carbon fiber to end ring
