1 Problem

Tacoma Narrows Bridge Collapse

Cause Map™ Diagram

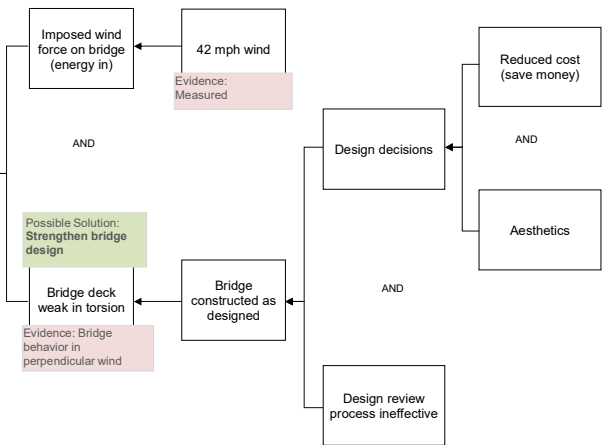
On the morning of November 7, 1940, the movement of the Tacoma Narrows bridge changed from the usual longitudinal motion to a never before seen twisting mode. The peak twisting motion is estimated to have been 25 ft from crest to valley. The bridge was closed to traffic due to the unsafe conditions. The violent twisting motion continued to increase for about an hour until the suspender cables snapped and 600 ft of the roadbed was dropped into the river below. The Tacoma Narrows Bridge was destroyed a little more than four months after it opened.

As the Cause Map diagram demonstrates there were many causes that contributed to the collapse of the bridge. Wind was one of the more obvious causes. On the day the bridge failed, the wind was blowing across the roadbed at 42 mph, the strongest wind the bridge had experienced. Another cause was the design of the bridge. The Tacoma Narrows Bridge was particularly narrow relative to its length, making the roadbed more flexible than other suspension bridges. Additionally, the bridge had shallow girders and was relatively weak in torsion compared to other suspension bridges built around the same time. The overall design of the bridge resulted in a structure that was weak in torsion and moved relatively easily in the wind.

Ref.	Possible Solution	Cause
1	Wider roadbed	Narrow in relation to length
2	Stiffening struts	Roadbed was too flexible
3	Open lattice trusses	Solid trusses
